# STRUCTURAL PROBLEMS IN ITALIAN SCHOOL BUILDINGS OF THE LATE NINETEENTH CENTURY: THE SCHOOL "REALDO COLOMBO" IN CREMONA

## 3 THE SCHOOL «REALDO COLOMBO» IN CREMONA

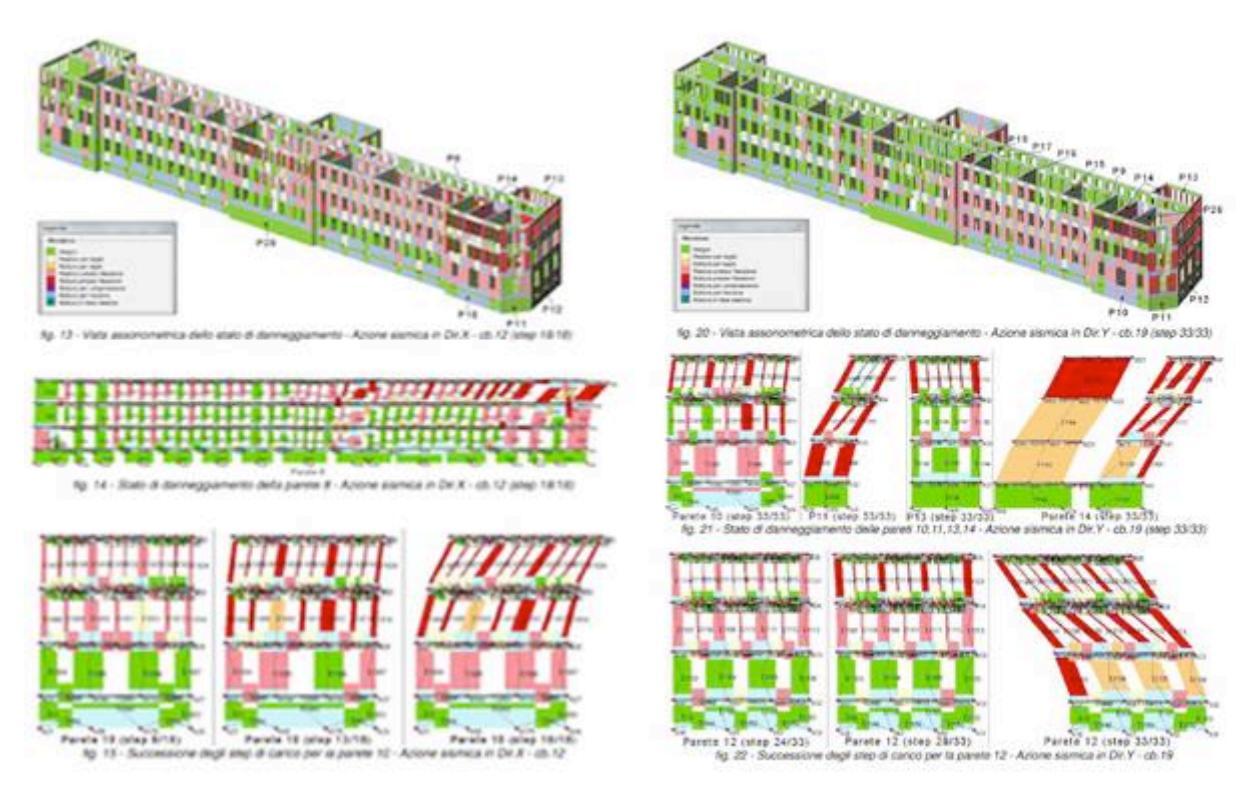
The structure was analyzed as a block, using a three-dimensional modeling equivalent frame, in order to determine the capacity curve of the structure V/d and compare it with the displacement provoked by an earthquake. Historical research and numerical data obtained from diagnostic tests have allowed us to characterize the individual structures composing the three-dimensional model. The purpose of structural modeling is to identify the critical issues in the event of an earthquake, excluding some variables from the model regarding small discontinuities to the walls which would have unduly overloaded the computational model without adding new information. Despite the good quality of materials and their correct application critical issues emerged regarding the resistance of the building to earthquakes, even when not very intense: the length of the building results in issues regarding the central body and the protruding end blocks, where damage would occur resulting in a partial collapses. The pattern of cracks in the building is limited, especially on the lower floors, the buildings to the sides and the gym: the first show a twisting under the effect of wind and of past earthquakes with lesions to the floor and ceiling, while the gym has (at the top of the perimeter walls) an almost horizontal cracking, evidence of shearing stress caused by the horizontal thrust of the main building. The instability increases on the second level where the cracks in the ceiling and floor are widespread and regular: ceiling damage follows the sequence of metal beams along all the corridor and, in part, also in the classrooms, while in the west wing a continuous gap is evident at the corner between the floor and the external wall of the corridor; it is immediately obvious the way that the iron and brick floor has absorbed the thrusts in a more widely distributed manner compared to the reinforced concrete pavement that is clearly cracked at the connection with brick walls. Cracking phenomena, apart from those attributable to local failures, are entirely absent on the side walls.

Figure 5: Structural 3D model of the «Realdo Colombo» school in Cremona. In case of earthquake, the head of the east wing could collapse. In detail the third level, characterized by a loggia, appears more vulnerable.

In light of the problems described, the project was divided into proposals for action limited to those parts of the complex necessary to achieve a degree of safety consistent with the regulations and to ensure, in the event of an earthquake, only localized subsidence of the structures. The demolished transverse partition walls between the classrooms are to be replaced with metal beam lintels connected to the surrounding walls with metal frames; in the long corridors the partitions with wooden portals that separated spaces and stiffen the building will be rebuilt. In the existing partitions wooden portals will be encircled with a metal frame that ensures greater resistance to torsional stress. Additional walls with portals will be placed along the corridor to improve the stiffness in the Y direction, i.e. transversally to the hall: as an example a frame will be added to the landing of the staircases to connect the east perimeter wall with the external wall of the buildings which project outwards towards the courtyards. A second project concerns the metal frames of the windows on the first and second floor of the protruding buildings, namely those at the middle and end: on the first floor the frames will be included in the splays inside the window openings, recomposing the structural continuity of the masonry, stiffened at points of discontinuity. Upstairs, where the front loggia is the site of a serious example of instability, it is necessary to insert external metal frames between the columns, connecting them to each other. This consolidation reestablishes the structural continuity in the event of an earthquake, limiting outward rotation or rotation of the columns that work as genuine connecting rods. Finally sixteen metal chains will be installed at the floor of the attic along the central building and the two wings, with the aim of preventing a tipping of the façades.
