The Complexity and the Logic Behind Historical Buildings: the Case-Study of Palazzo del Podestà in Mantova, Italy

Abstract The Palazzo del Podestà, situated in the centre of Mantua, has Medieval origins, but it is the result of many additions and reconstructions and it is now abandoned. In 2005 the Town Council commissioned the Politecnico of Milan a research on the real situation of the palaces, in order to determine the future possible uses of the buildings. The causes of the structural decays were investigated and furtherly studied by means of a comparison between archive records and diagnostic tests.

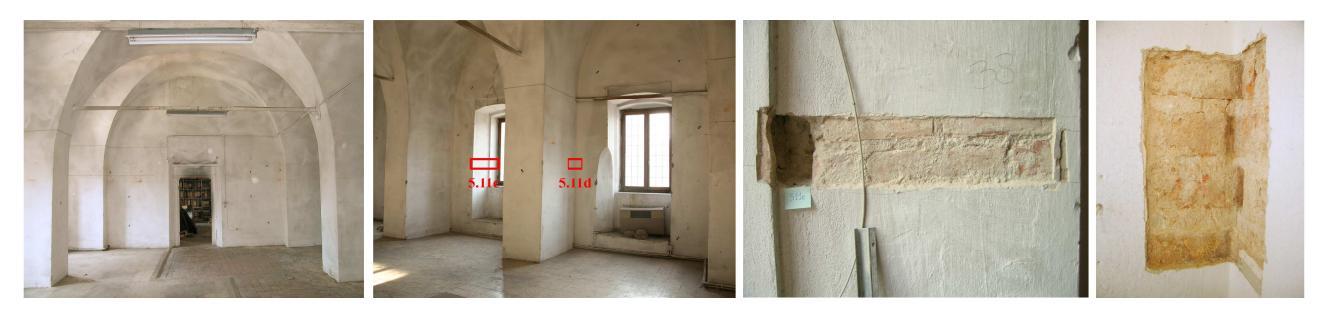
Figure 2: From left to right: pictures of the rectangular room on the third level. Site of the two stratigraphic tests on the wall. Stratigraphic test n° 5.11c: it confirmed that the exterior wall of the building is formed of two well-distinguished brick walls: the hole on the left was completely filled with mortar. The stratigraphic test n°5.11d, made on the edge between the outer wall and one of the four piers: the brick masonry of the pier and the wall are tightly connected

Although some archives are incomplete, it is possible to express a hypothesis about the building. In 1413 a fire destroyed a part of the palace and in 1466 Ludovico II, Marquis of Mantova, gave the architects Luca Fancelli and Giovanni Antonio d'Arezzo the task to definitely arrange the façade looking on to *Piazza delle Erbe* (Carpeggiani and Lorenzoni 1998, Vatovec 1979). They probably had to deal with pre-existing composite structures set against the medieval nucleus of the palace. Probably the architects' restoration consisted in enlarging, raising and rebuilding the façade so to give dignity to the public square. On the lower floors a faced wall was set against the existent brick masonry in order to thicken it: so both structures could better support the load of the added upper storeys and wooden floors. At first this hypothesis was considered only by the historian Giovanni Paccagnini (Paccagnini 1961); now it is confirmed by a test carried out on the internal side of the façade looking on to *Piazza delle Erbe*.

The test suggests the presence of two well distinguished brick masonry walls: nowadays the windows are in the outer faced wall, but the test shows the presence of an inner seat of a window.

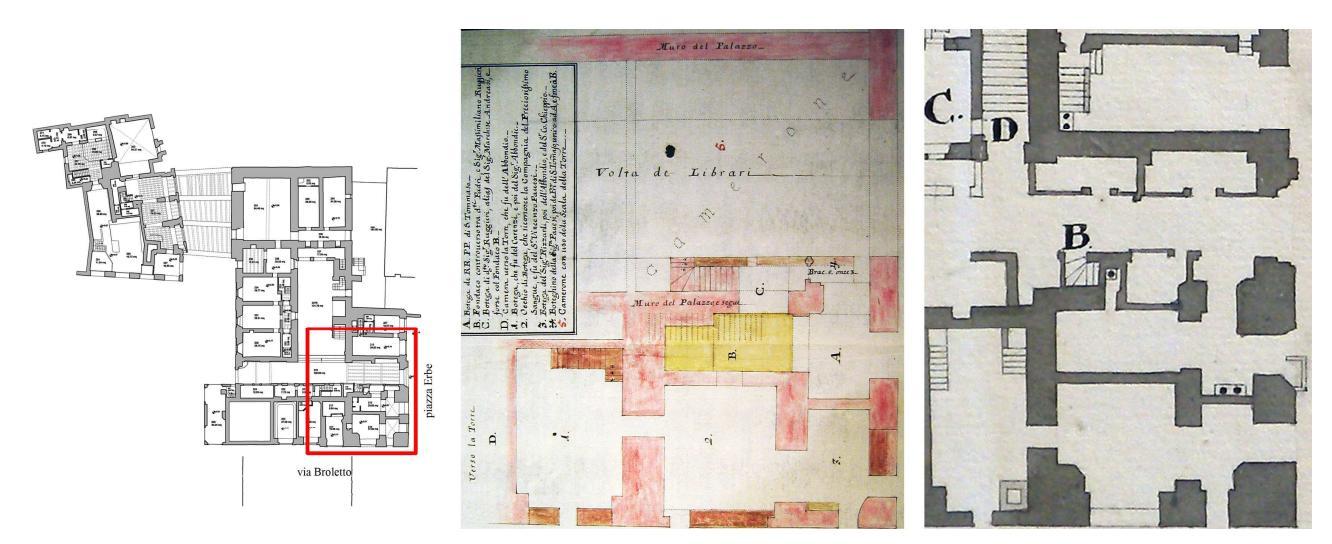
Figure 3: From left to right, the ground level of the Palazzo del Podestà facing piazza delle Erbe; a survey of the same part of the building dated 1722, by Doricilio Moscatelli Battaglia; survey by Paolo Pozzo, dated 1794, shows many different features if compared to the previous one: it can be noticed the thicker external walls on the northern and western side, the presence of three masonry piers inside the corner rooms, some different openings and the resizing of the vicolo Lattonai (where a new shop was built).

The last cause was the result of a progressive chiselling into the walls on the lower levels made by the shopkeepers in order to have larger rooms. Doricilio Moscatelli's survey dated 1722 (ASMn, N, b.2212) shows an enlargement of the shop-openings on the ground level involving a thinner wall thickness, if we make a comparison with another survey dated 1794 (ASMn, MCN, b.140). Besides other further causes can be added:

The previous arrangement of the arch and of the rooms on the ground level towards Piazza delle Erbe is given evidence by a fresco and by a survey made by Moscatelli Battaglia in 1722.

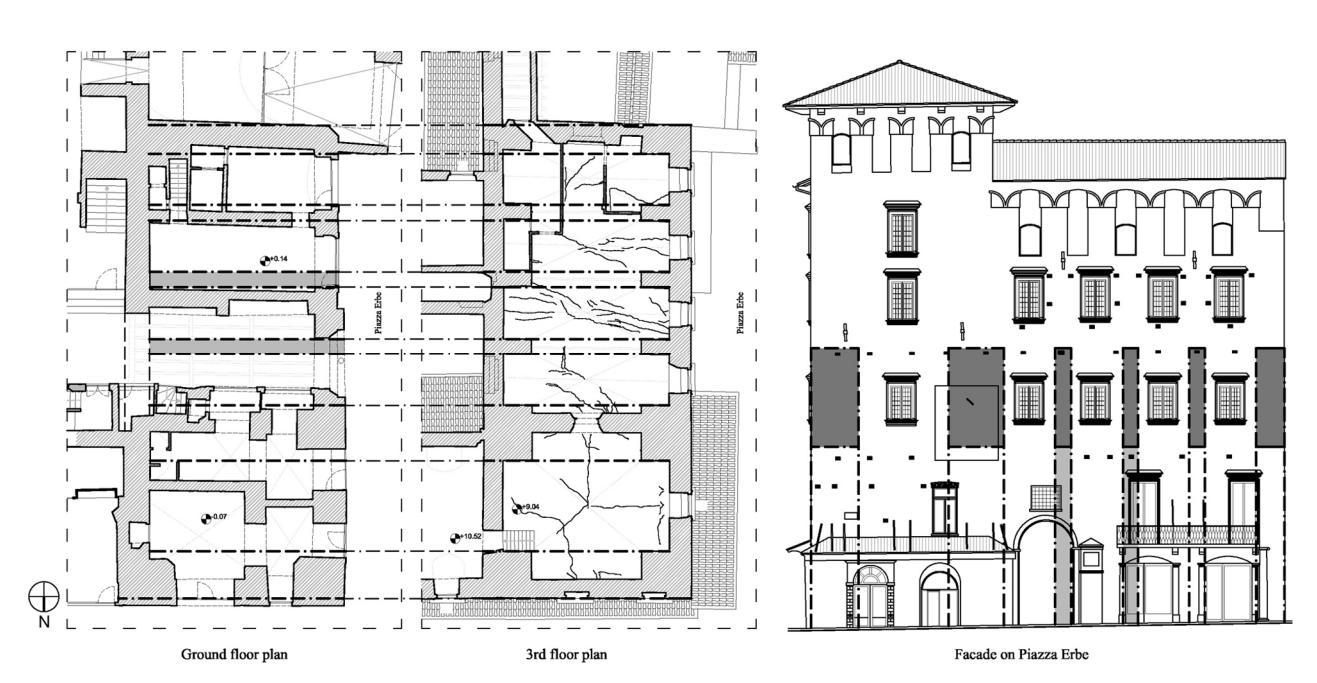
Figure 4: On the left, the ground and the third level of the building facing piazza delle Erbe: the dashed lines show the projection of the piers of the third level on the ground level structures. On the right: the façade looking on to piazza delle Erbe: the projection on the façade of the inner piers on the third level are coloured dark grey. In some cases, at the lower levels, the faced wall shows some openings just below the piers (coloured light grey)

The present cracks over the windows spread in correspondence of the first two vaults; the pier separating them does not rest on an underlying wall, but directly on the barrel-vault over vicolo Lattonai. On the contrary the next pier, between the second and third vault, results eccentric – in all its whole thickness – as regards the underlying wall.
